Victor Division  
**RCA Victor Company, Inc.**  
Camden, N. J.

**Service Bulletin No. 10**

**AIR LID SUPPORTS**

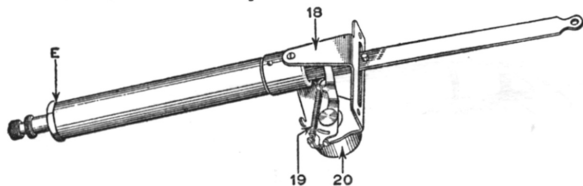
Fig. 4

5. If the lid still closes too fast, there is probably leakage around the joint at E, Fig. 4.

- Remove the cap, and distribute some bees wax in the threads of the cap and the tube.
- Replace the cap, and tighten securely.
